Pre-Purchase Building Report

12 February 2009

13 West Street, Bexley

Pre-Purchase Inspection - Residential Building Report

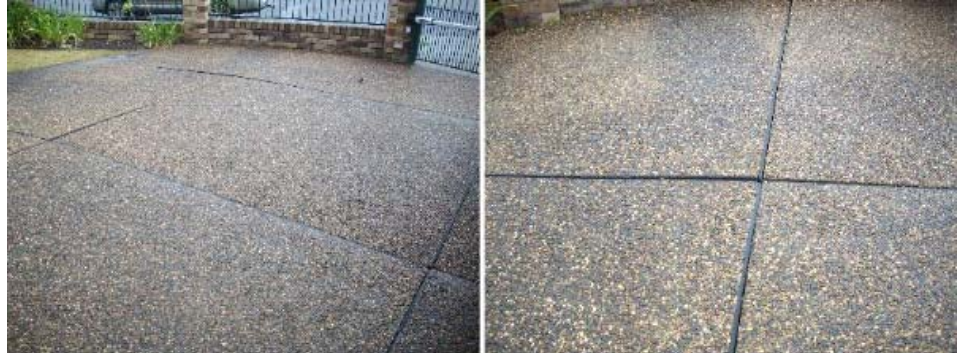
- The concrete is lifting - minor.

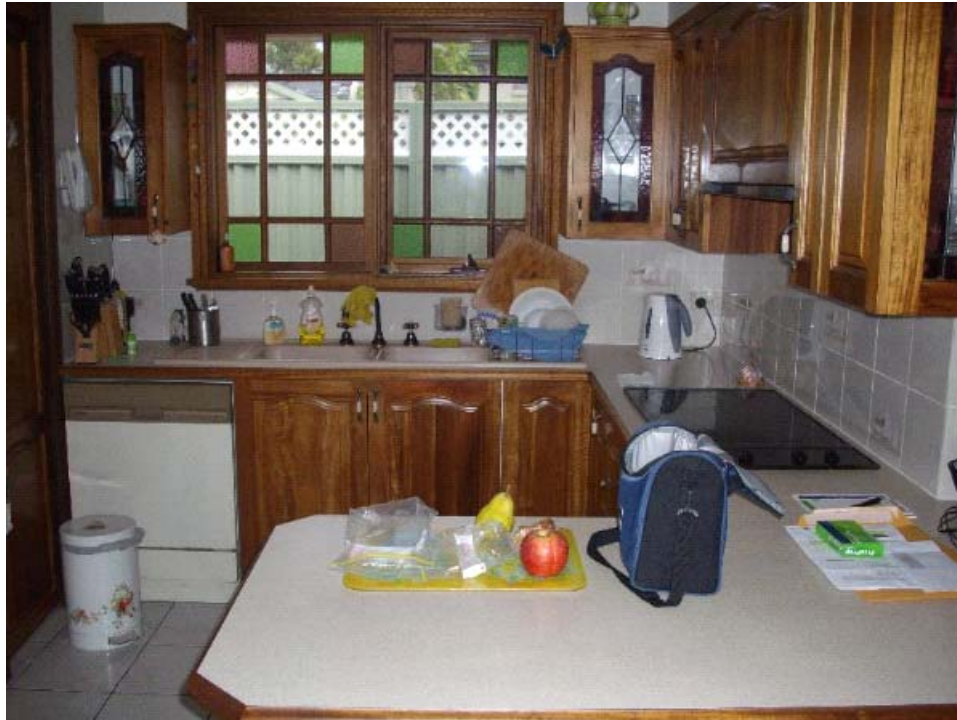
- Cupboard door hinges are out of adjustment.
Wear and tear to doors noted

We recommend you arrange for a handyman/tradesman to rectify the following minor repair items	
1. Adjust striker plates to internal doors. 2. Adjust kitchen cupboard doors. 3. Remove timber formwork to sub floor area	
Overall allow :	\$500

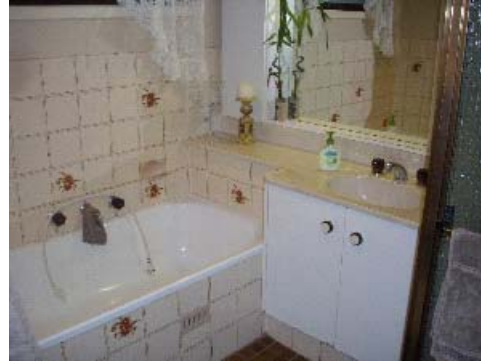
- Wear and tear is noted to the vanity cabinet.
- The vanity unit is nearing the end of its economic life and replacement should be considered.

The following items should be subject to a further detailed investigation by a licensed tradesman to enable an accurate estimate of cost to be provided.	
1. Renovation of bathroom

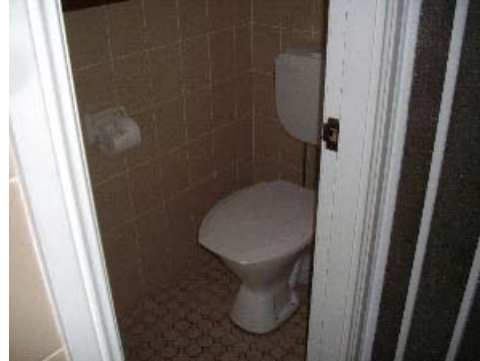
- The toilet pan is loose at the floor and needs to be re-set.

The following items may require the attention of a licensed tradesman.	
1. Resecure sagging garage ceiling prior to painting and re set joints.	\$500
2. Re set loose toilet pan	\$200

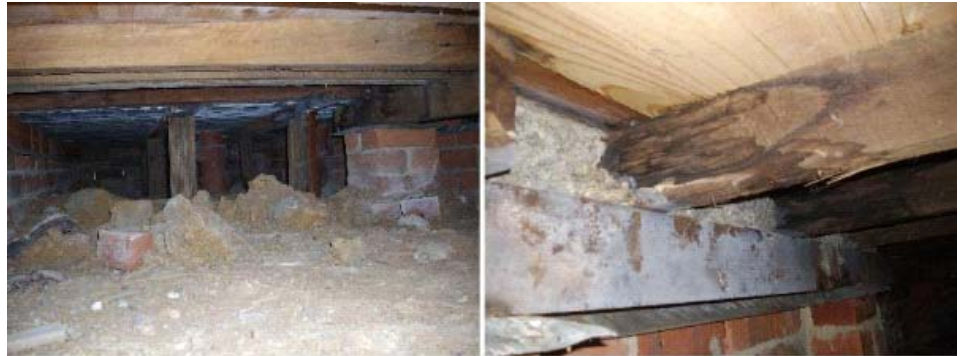
Timber formwork still in place having contact with the ground, could attract termites and should be removed.

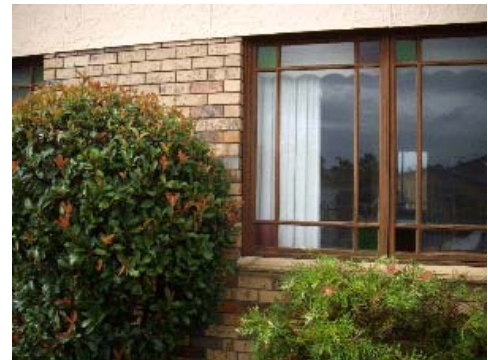
- Settlement cracks to brickwork - Appearance defect

If settlement cracks or gapping exist, the only way to determine whether movement has ceased is for the cracks/gaps to be monitored over a period of time. If future movement ranges more than about two or three of millimetres, a structural engineer should be consulted.
